# Safety at Kerbside Tram Stops – Accident Analysis and Mitigation

## **PAPER NUMBER 11-1640**

Submitted for publication and presentation,  
Transportation Research Record

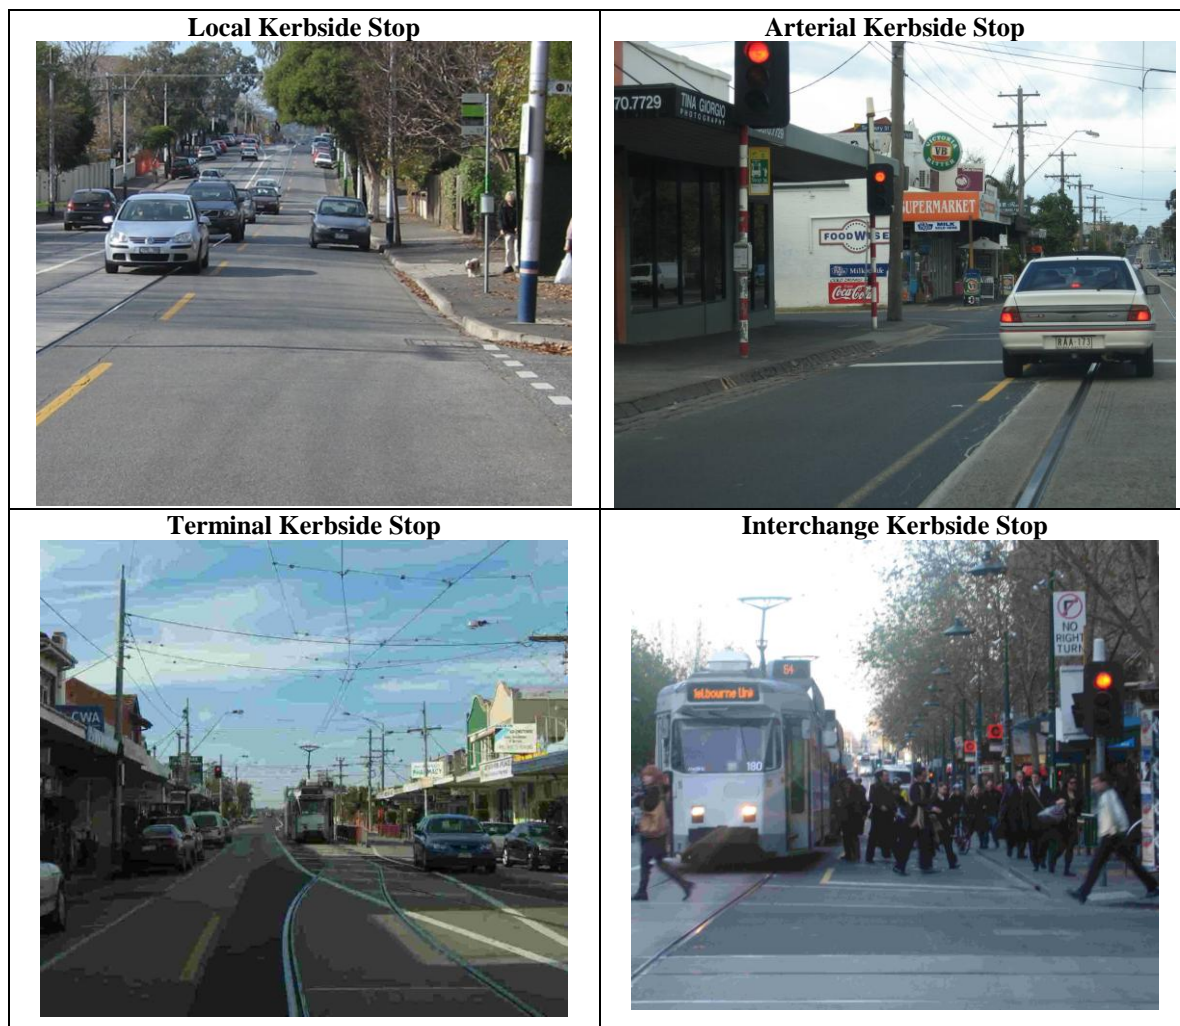
FIGURE 1 : Location of Features of Typical Kerbside Tram Stop Types

**TABLE 1 : Key Features of Typical Kerbside Tram Stop Types**

Most kerbside stops are 'local' stops on lower order roads. Trams don't always stop at these locations since stopping is on demand. Tram drivers tend to let cars behind the tram get past the tram before stopping since traffic volumes are not high. Since streets only have local traffic auto drivers have some likely familiarity with passengers and can be very concerned to stop (these is little thru or non-local traffic). From a passenger viewpoint cars in the vicinity of local stops is not common and there are many expected breaks in traffic when getting to/from trams.

Arterial stops are much busier and congested with much through (non-local) traffic. There can often be more than one traffic lane between the kerb and the tram and tram stopping is much more frequent. Auto drivers are often keen to avoid delays when passengers access the road lanes so often rush past trams as they are slowing. Conversely passengers are aware of busier locations and may take greater care. Terminus tram stops are confusing for auto drivers since trams often wait for return trips in these stops so drivers are unclear if this is a tram with departing passengers or its empty. Road rules are unclear in these conditions. Passengers however are often keen to get to/from the tram before it leaves making for a dangerous mix of passenger and auto driver behaviour. Intersection stops are where passenger transfer between lines occur. Here road conditions are often ambiguous since two sets of trams are present at an intersection with turning traffic. Passengers rushing to make connections can add to safety concerns.

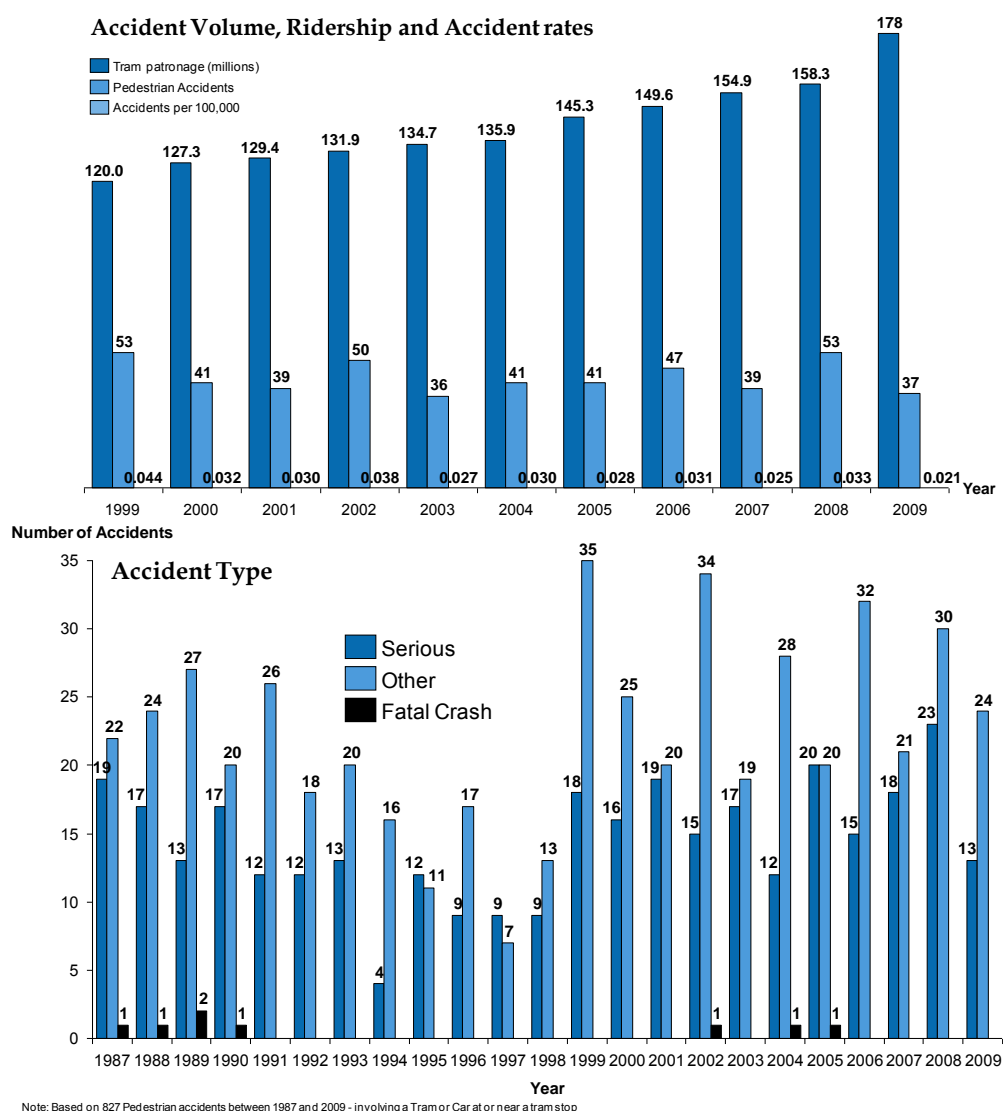
**FIGURE 2 : Historical Trends – Accident Rates by Type**

Accident volumes between 1999-2009 have occurred at between 38 and 53 p.a. with no particular trend. However ridership has grown considerably so accident rates per rider have fallen. Rates per 100,000 riders have fallen by over half from 0.044 in 1999 to 0.021 in 2009. There are no clear patterns in type of accident however fatalities are rare (one every 3 years on average) however interestingly all accidents during this period involved people aged over 55. 'Other' accidents tend to be the most common type. No trends in type of accident are apparent.

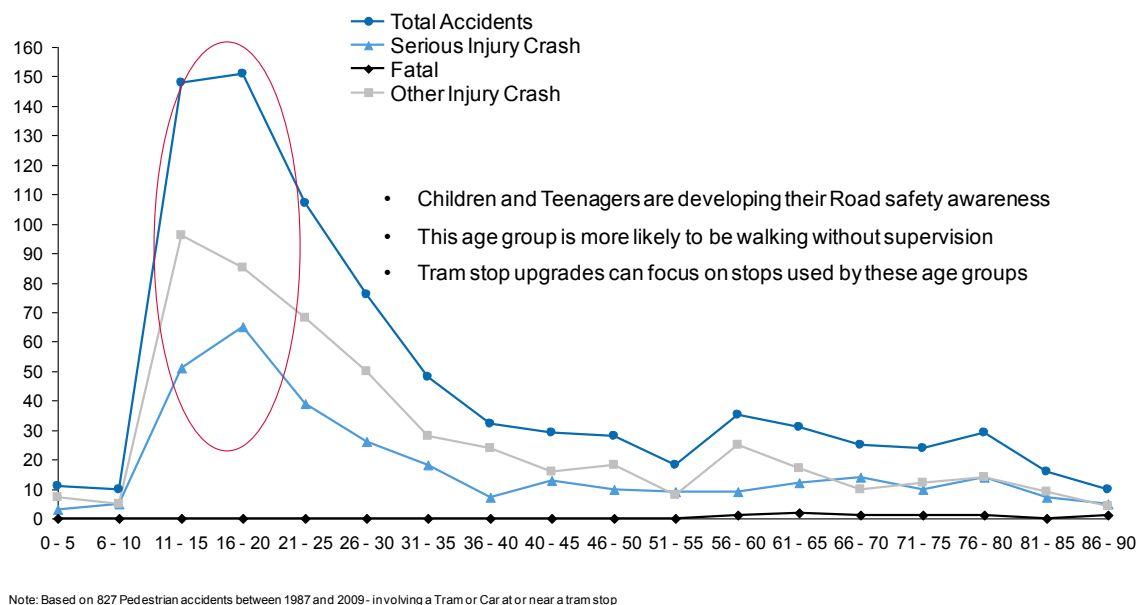
**FIGURE 3 : Tram Accident Types by Age Group**

Children over the age of Ten and Teenagers are at greatest risk. Issues associated with this group are road safety awareness, lack of supervision and groups of boisterous unruly school children carrying school bags without a high degree of concern for road safety.

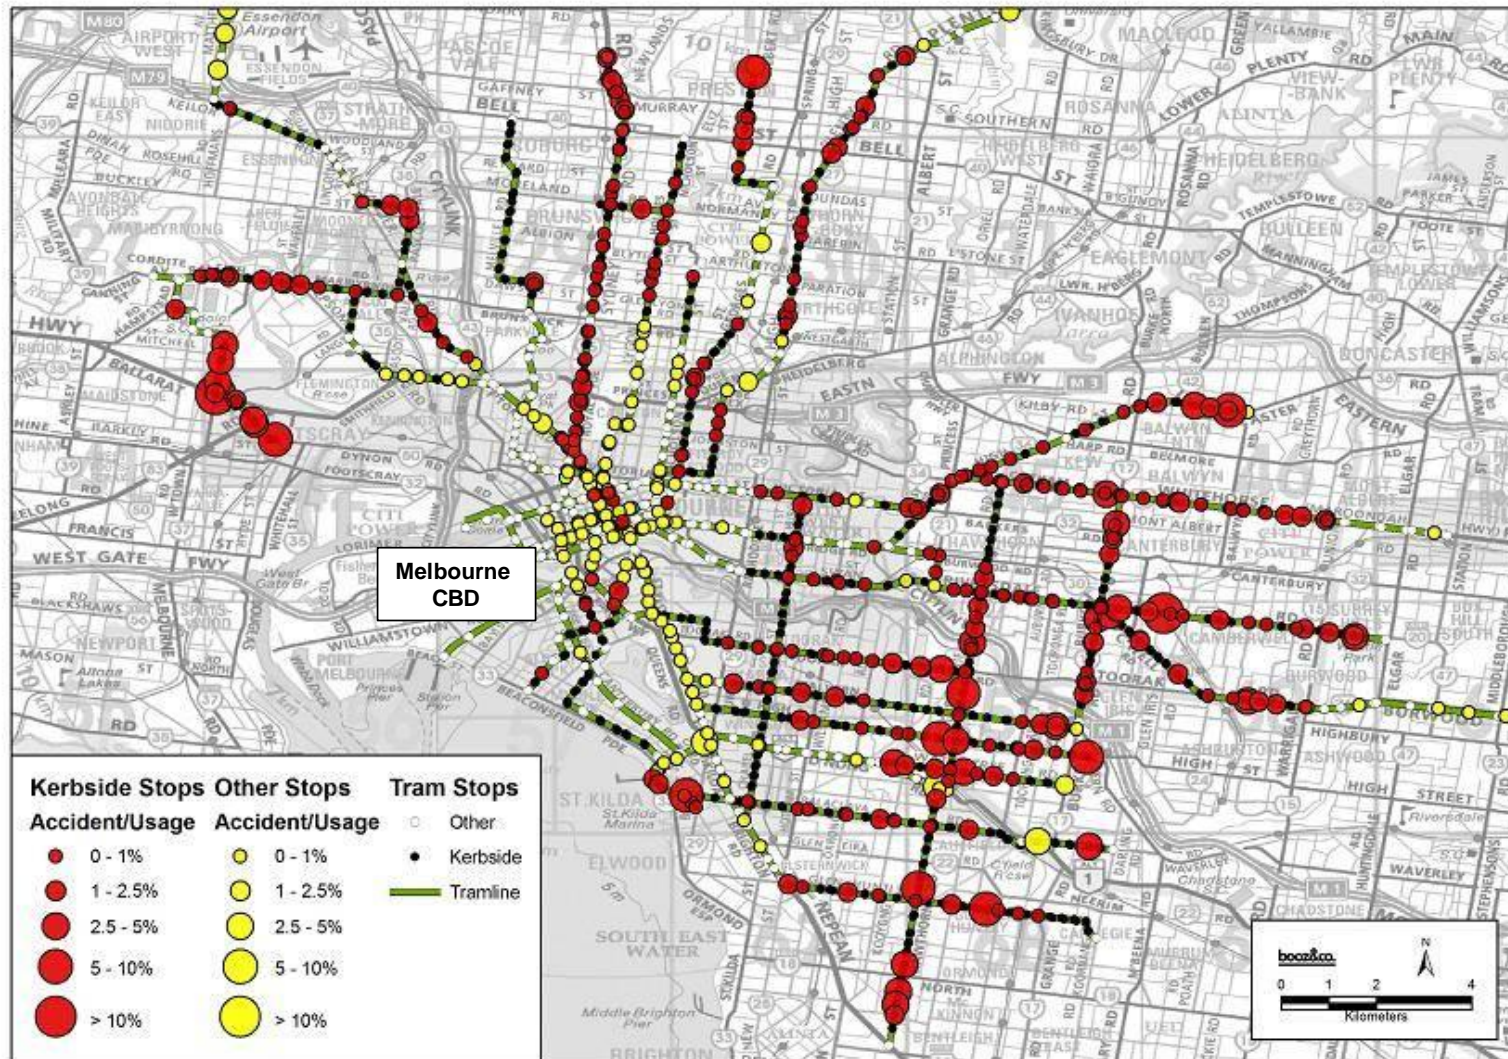
FIGURE 4 : Tram Accident Volume by Stop – Kerbside and Other Stops

Figure 4 shows the results a plot of accident volume by stop for all kerbside and other stop types. It is clear from this that kerbside stops are the most concerning from a design viewpoint. Indeed the analysis established that 65% of all accidents occurred at Kerbside stops while they actually represent only 61% of stops. By volume of passengers however this ratio is far more alarming. CBD stops, which are now mainly of platform design, are much busier but have very low accident rates.

Figure 4 also demonstrates some very important findings about the uneven spatial distribution of accidents within the system. Terminus kerbside stops (at the end of lines) have an abnormally high representation in the data as do interchange kerbside stops located where two sets of lines intersect. There is also a very concerning 'hot spot' of kerbside accidents to the West of the network on services operating on route 82 in Footscray. Some localised accident rates are very high. It is estimated that commuters consistently using selected tram stops each weekday will have a 10% change of an incident within a 20 year period.
